ADVERTISEMENT FOR SEALED BIDS
SALE OF COUNTY PROPERTY
(Old Bethel School Property)

FEASIBILITY ASSESSMENT OF OLD BETHEL ELEMENTARY SCHOOL

Asbestos Survey Report

Old Bethel Elementary School

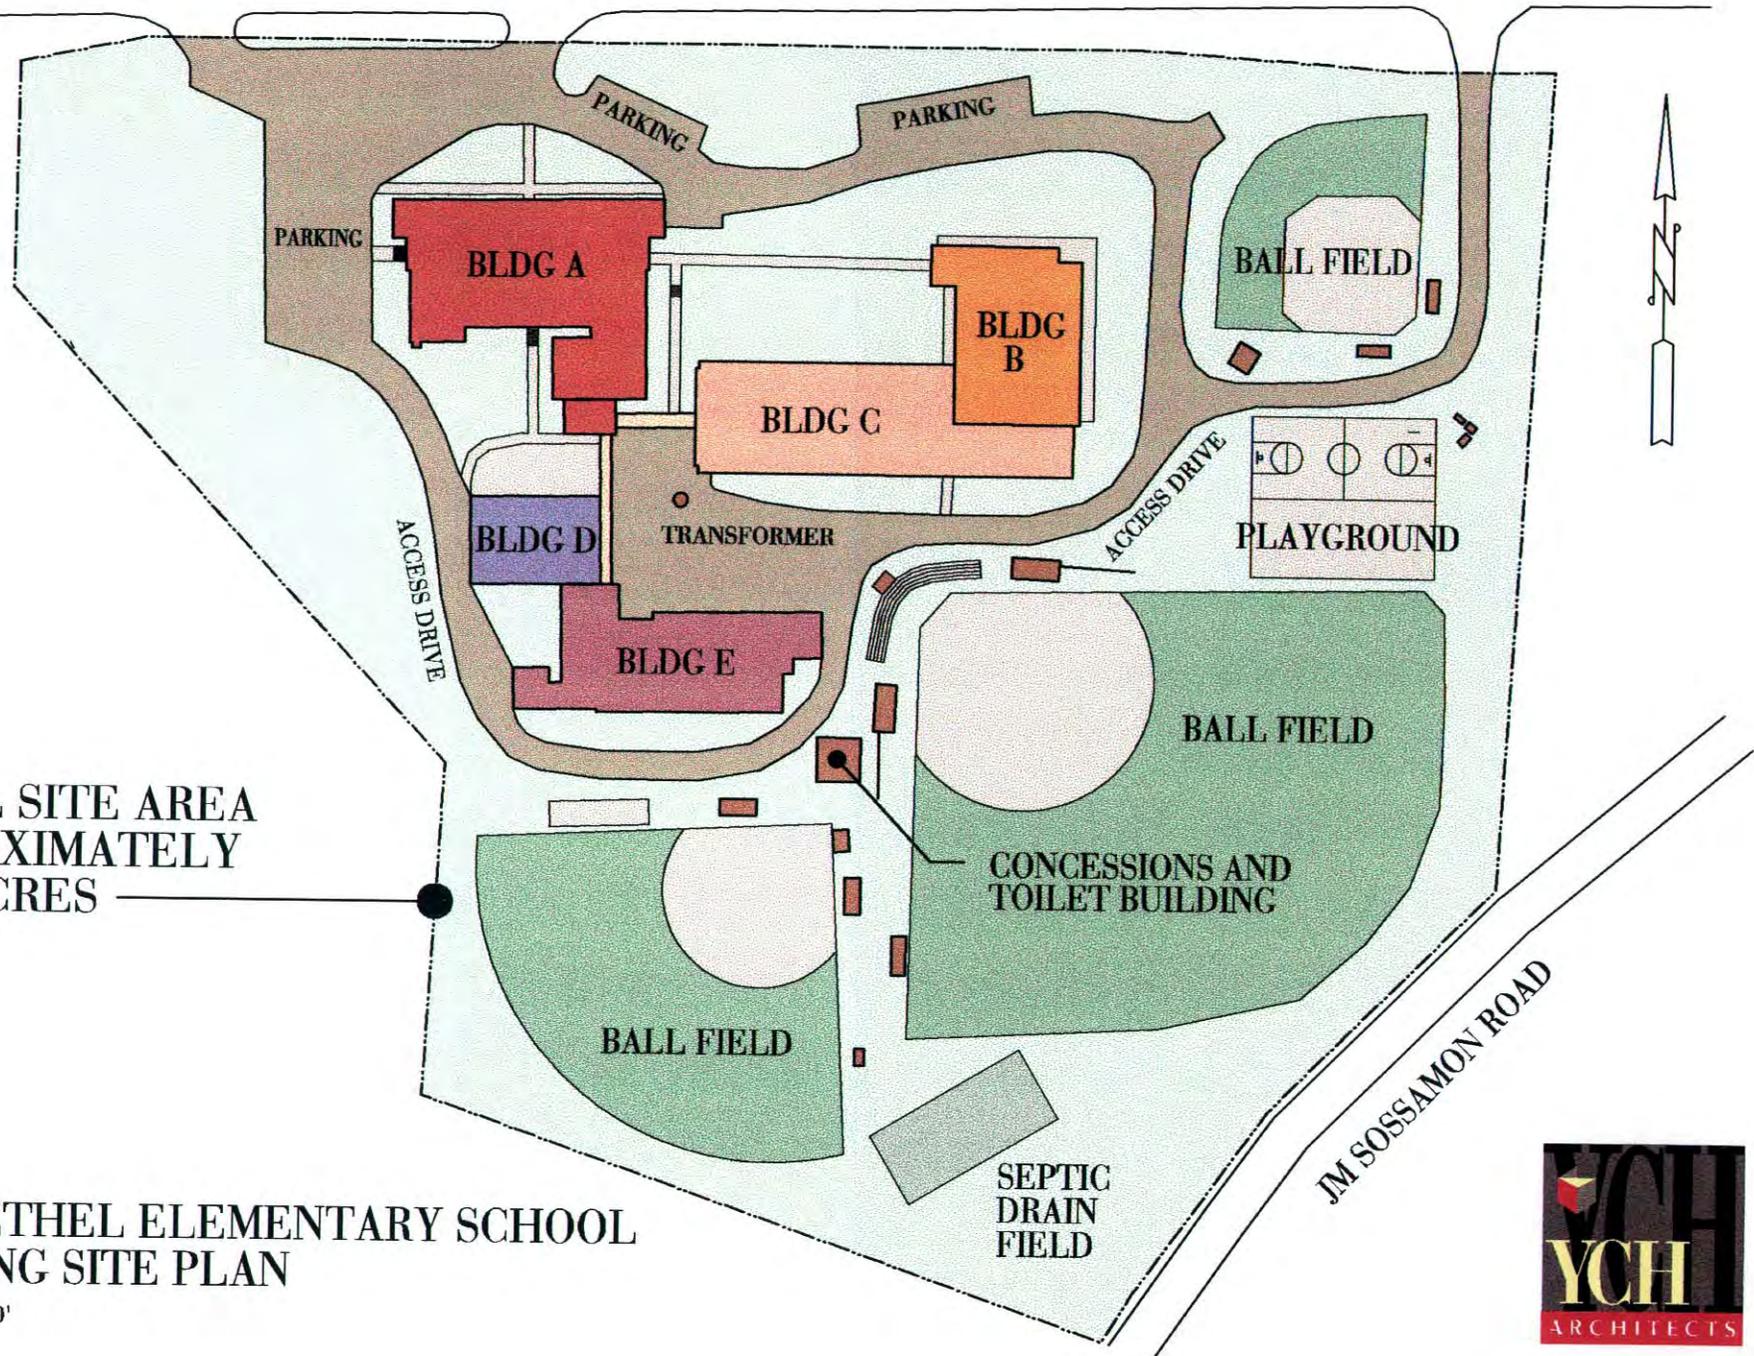
OLD BETHEL ELEMENTARY SCHOOL
EXISTING SITE PLAN

With the exception of the water line and fire hydrants, many of the site improvements are almost 50 years old and have deteriorated significantly. The asphalt paving is in very poor condition throughout the site due to cracking and numerous potholes. The walkway covers between buildings are all in poor condition, rusting and are ponding water. All of the storm water runs off site in an uncontrolled manner, most of it down through the ball field area. Much of the underground water distribution and sewer collection systems were installed in the late 1950's and have shown evidence of being in poor condition due to ongoing operational problems reported by Cabarrus County Schools.

Most of the asphalt paving should be removed and replaced on re-compacted earth and stone base. The access road to the back buildings and ball fields should be widened to 2 full lanes for emergency access if the ball fields continue to be utilized. Grades throughout the paved and other site areas should be adjusted and storm water inlet structures with underground piping installed to better direct and discharge the run-off. Depending on the ultimate use of the buildings, additional asphalt areas for parking and more concrete walks for access to buildings should also be installed. Any significant increase to the impervious area may require on-site storm water retention according to the current ordinances.

A new fire water line needs to be installed to supply buildings that require sprinkler systems and also at least one additional fire hydrant added near the middle of the site. The existing underground water distribution and sewer piping are close to 50 years old and in need of complete replacement.

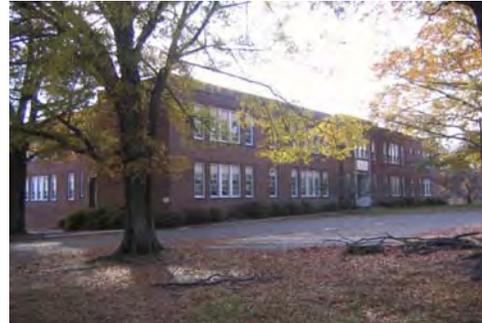
The building has been vacant for about a year and a half with the plumbing, mechanical and electrical systems having been completely shut down. The interior of the building has significant damage, apparently from vandalism - such as broken windows, damage to lay-in ceilings, holes in plaster/drywall walls, damaged HVAC units and plumbing fixtures, etc. The newest components of the mechanical and electrical systems are between 20 and 25 years old and at the very end of their normal life expectancy. The majority of the plumbing system is much older due to the piping concealment below grade and within walls of the building. Almost all of the accessible copper piping has been removed, and the galvanized piping has deteriorated significantly.

There is evidence on the interior of several significant roof leaks. In addition, it has been reported that the brick exterior walls are very porous and water has “wicked” through to the inside and damaged finishes applied to the exterior wall. The Cabarrus County Schools have indicated a sealer was applied to the exterior brick as a temporary measure to alleviate the moisture penetration to the inside, which was provided only as a temporary topical solution and will need to be reapplied soon. The roof showed significant blistering and bubbling throughout the entire surface. Two areas of standing water were observed on the roof, which were located near the areas of the water damage on the interior. An asphaltic material has been applied to the top surface of the precast concrete parapet wall cap. The porous nature of the precast material and the joints between individual pieces usually allow water down into the exterior wall, which is most likely why the asphaltic material has been applied.

The building appears to be in satisfactory condition structurally. Although several cracks in the exterior wythe of brick are evident from the outside (some of which have been previously patched), there is no visible evidence of significant structural instabilities in the masonry exterior bearing walls. However, the mortar joints near at the top of the wall have deteriorated, presumably due to water passing through the parapet wall from the roof side. The wood floor above the crawl space on the main level shows some evidence of termite damage, and the joists have been shored up from the crawl space below in some locations. This damage to the wood floor joists appears to be isolated to the bearing pockets within the brick foundation walls, which is very typical in buildings of this construction and age. However, the floor shows no signs of failure at this time. Further investigation into the presence of active termites and the extent of damage should be pursued.

The building is in need of a complete new roofing system. This is also the best opportunity to provide insulation for the building, since it cannot be provided within the existing walls. A significant amount of heat gain in a typical building is through the roof surface. The existing roofing material should be removed down to the existing structural roof deck - of which the wood components will most likely need to be patched or completely replaced if water penetration has damaged it as expected. A new fully adhered EPDM or TPO roofing over rigid insulation should then be applied. The insulation should be tapered to provide adequate slope to the scuppers that would eliminate standing water. This will bring at least the roof surface into compliance with the current North Carolina Energy Code. Lastly, the new roof membrane should be turned up the back and up over the top of the parapet wall and capped with a metal parapet coping that would eliminate the water intrusion from the back or top of the parapet wall that was previously experienced with the precast concrete parapet cap.

To achieve higher insulating values at the existing exterior walls, rigid insulation within furring channels could be attached to the inside face of the existing exterior brick walls. Drywall could then be attached to the furring channels for a finished surface. This should greatly improve the insulating quality of the existing exterior walls. The windows should also be replaced with better insulating types that would be more consistent with the historical image of the building. The exterior doors should be replaced with better insulating and weatherstripped systems. All of this will provide a better insulating building envelope, provide for better interior environment control for and reduce strain on the new HVAC equipment.

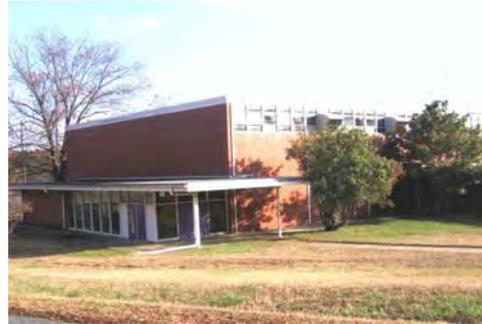
As with Building A, this building has been vacant for about a year and a half with the plumbing, electrical and heating systems having been completely shut down. The interior of this building does not have the extent of interior damage that has occurred in other buildings, but has some indications of vandalism. The heating system and plumbing appear to be original to the building and thus almost 50 years old. Due to their age and deterioration, the plumbing, mechanical and electrical systems are at the end of their life expectancy, except for the lighting in the gymnasium. However, since the power was turned off to the building, the lighting could not be observed. The exposed plumbing piping has visibly deteriorated, and it is reported that most of the fixtures in the locker rooms, including all of the showers, had been disabled several years ago due to ongoing problems.

There is evidence of roof leaks from the areas of the roof drains and evidence of a significant amount of water entering from high on the gym walls. This water is most likely entering through the clerestory windows that are not sealed, have been broken or simply left open. There are also signs of significant water entering where the lower roofs over the locker rooms and of Building C connect into the higher walls of the gymnasium. Access to the roof was not provided. However, standing water was observed around the perimeter of the high roof despite the addition of gutters, which is presumed to be in need of replacing. Several inches of standing water was also observed at the intersection of the low roofs to the high gym walls, resulting in the significant water intrusion in these areas. The wood gym flooring is in fairly good condition with no noticeable warping or buckling, but is in need of sanding and refinishing. There is a fine layer of dusty material coating the entire wood floor. This material needs to be investigated further to determine if it is material flaking from degradation of the roof deck, which could signify structural problems and warrant replacing the roof deck. The basketball goals were also very dated.

Pending further investigation of the roof decking, the building appears to be in satisfactory condition structurally. Several cracks in the CMU walls of the gymnasium are visible from the interior. While not load bearing, these walls provide the back-up system for the exterior brick veneer. There is no evidence of significant cracks in the exterior brick veneer.

Although it was only observed from a distance, the roof is presumed to need replacing. The steel roof structure is most likely completely flat and any slope is very minimal due to the built-up asphalt material. The existing roofing should be completely removed down to the decking and a new fully adhered EPDM or TPO roof membrane installed over tapered rigid insulation that would provide the correct slope to the external gutters and eliminate standing water. This would also provide the proper insulating value for the roof that would reduce the loads on the new HVAC equipment. An overflow roof drainage system should also be installed to meet the current requirements of the code.

The existing clerestory windows also need to be replaced with insulating windows and properly sealed to eliminate the water intrusion. The existing exterior glass at the entry lobby should be replaced with a modern, thermally broken storefront type system with insulating glass to provide better insulating values for the large expanses of glass. The exterior doors should also be replaced with better insulating and weatherstripped systems. The insulating value of the existing exterior walls should not be of significant concern, such as in Building A, due to the sporadic use as a gymnasium versus an occupied office space. Cracks in the CMU exterior walls need to be properly grouted.

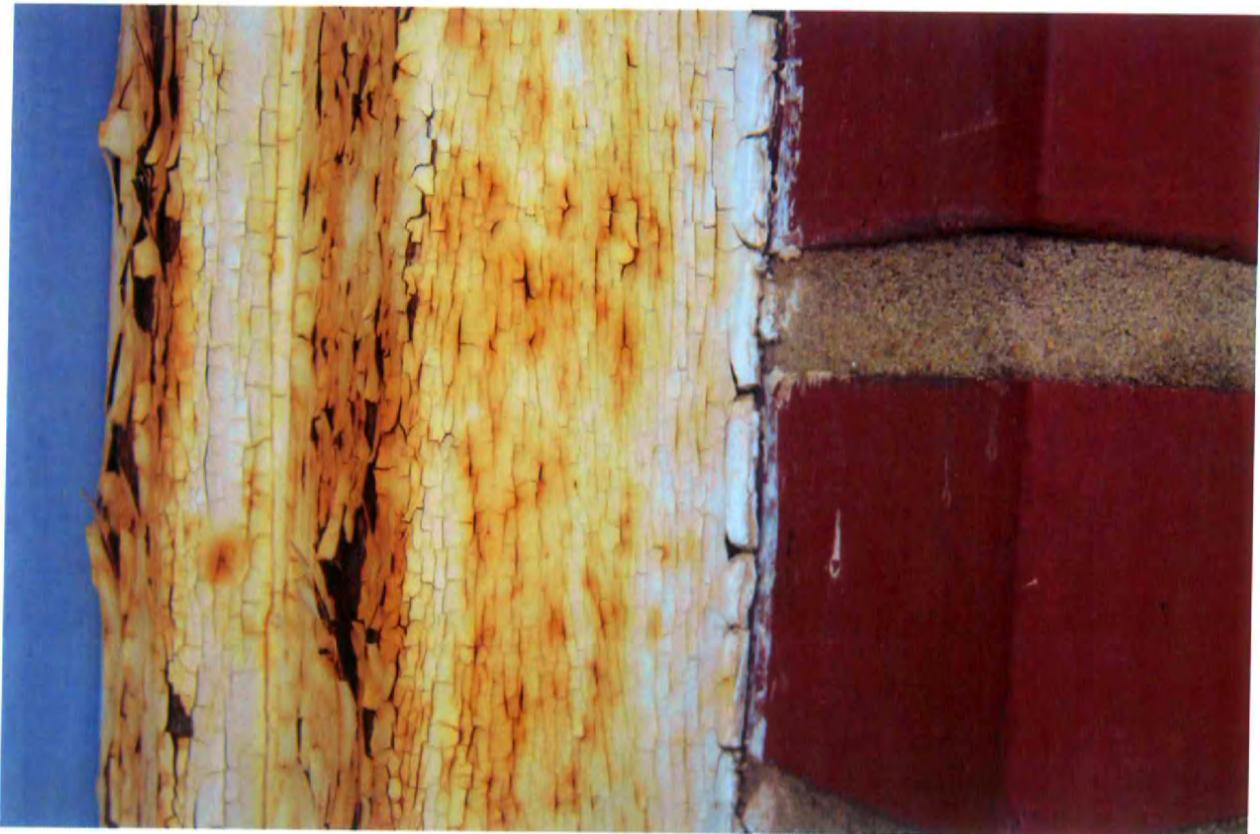
Photograph D-6 – interior window caulk

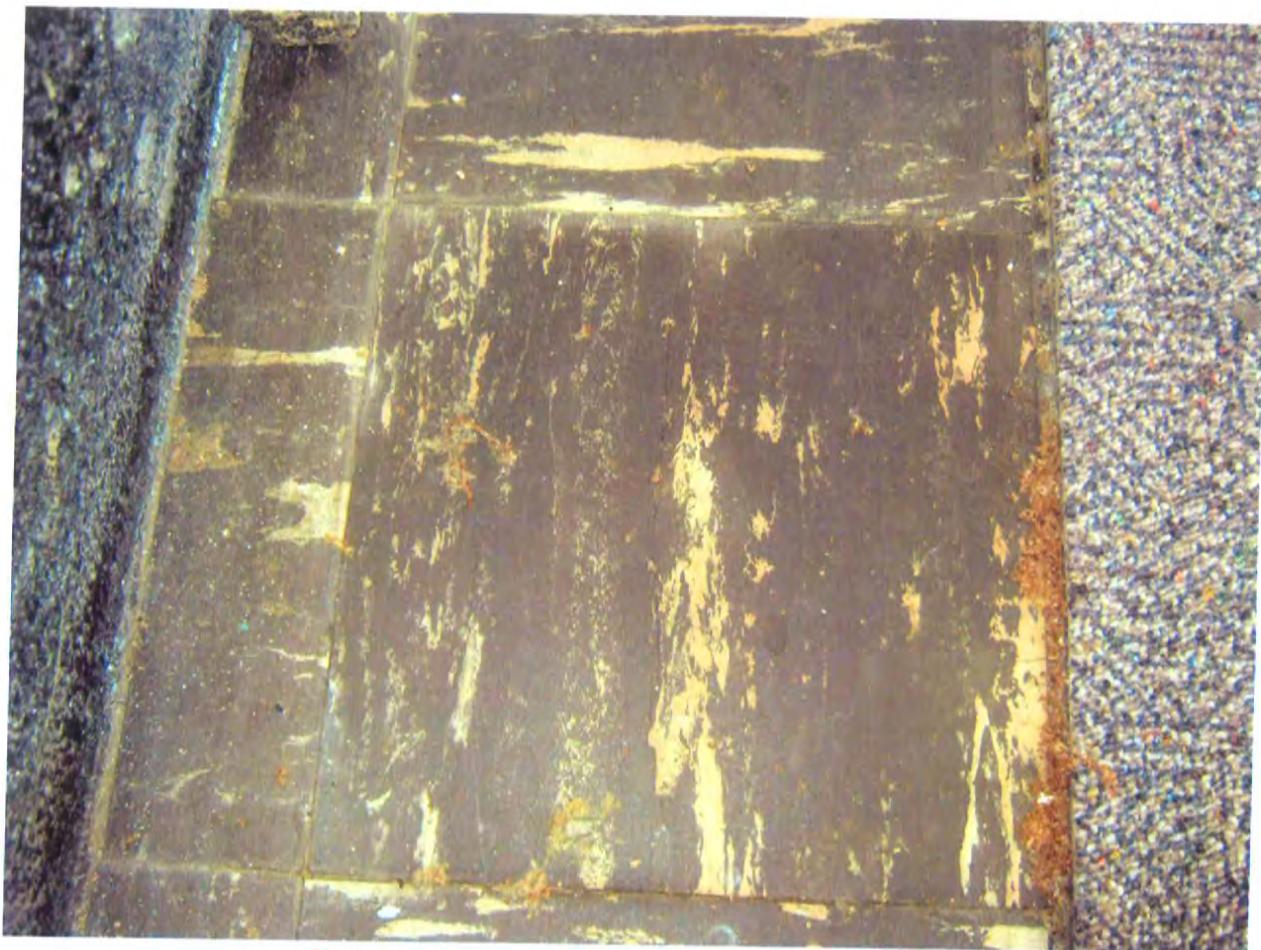
Photograph E-22 – carpet adhesive
