ADVERTISEMENT FOR SEALED BIDS
SALE OF COUNTY PROPERTY
(Old Bethel School Property)

FEASIBILITY ASSESSMENT OF OLD BETHEL ELEMENTARY SCHOOL

Asbestos Survey Report

Old Bethel Elementary School

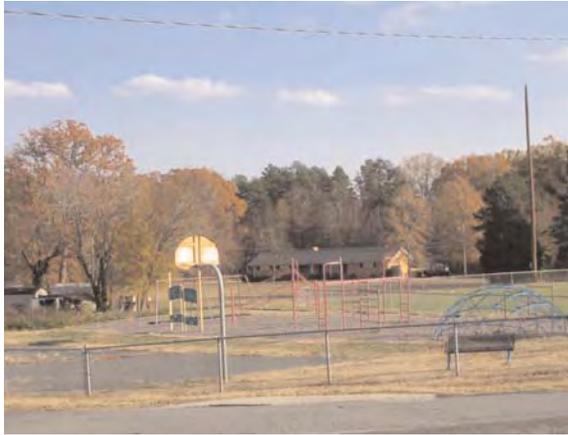
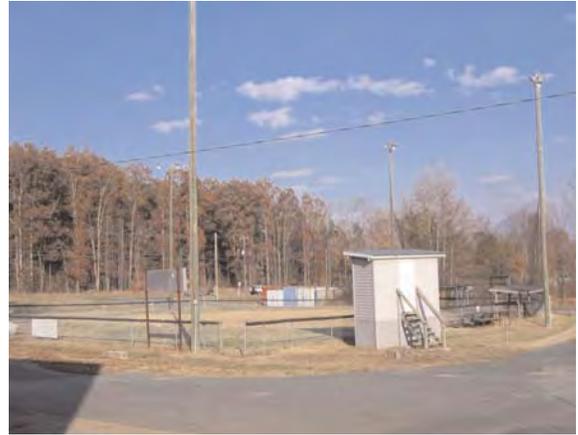
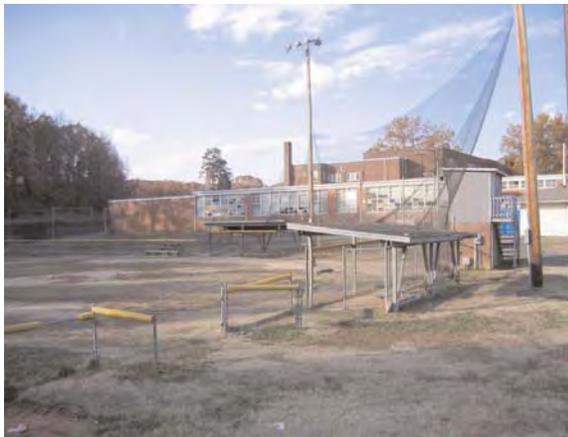
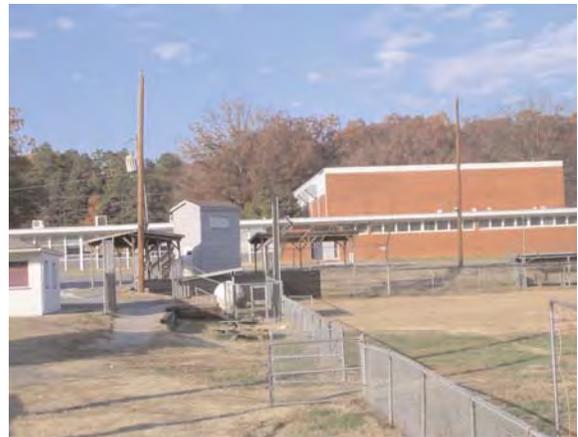
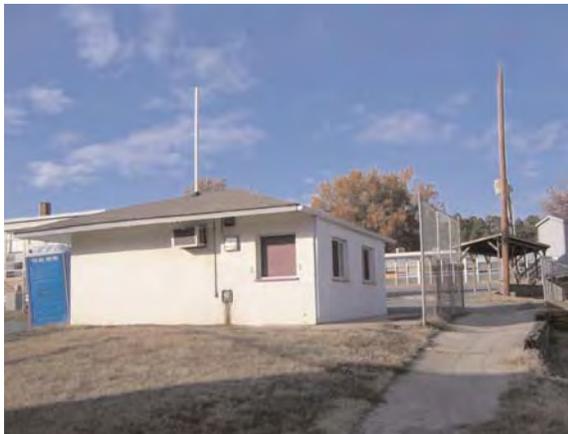
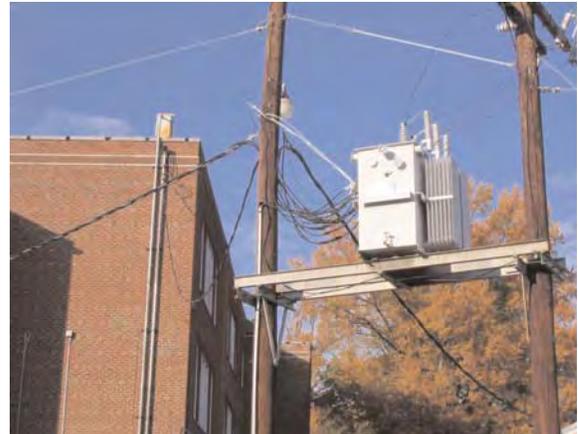
SITE PHOTOS

With the exception of the water line and fire hydrants, many of the site improvements are almost 50 years old and have deteriorated significantly. The asphalt paving is in very poor condition throughout the site due to cracking and numerous potholes. The walkway covers between buildings are all in poor condition, rusting and are ponding water. All of the storm water runs off site in an uncontrolled manner, most of it down through the ball field area. Much of the underground water distribution and sewer collection systems were installed in the late 1950's and have shown evidence of being in poor condition due to ongoing operational problems reported by Cabarrus County Schools.

The ball fields and playground have continued to be utilized by the community after the abandonment of the buildings. The very small upper ball field and playground appear to be in decent shape. The playground contains an area paved with asphalt for basketball which is cracked and partially covered with weeds and in need of removal or repair. The lower ball fields show evidence of drainage problems, since most of the storm water from the site drains down through this area. The concrete bleachers, chain link fencing and backstops and dugouts appear to be in adequate condition for continued use by the community with minor repairs. However, many of the light fixtures in the ball field areas have been removed from the poles due to instability and possible falling.

The toilet and concessions building was padlocked and not accessible. Utilities to this building have been shut off and portable toilets placed on site. The various announcer's / scoring towers and concessions / toilet building seem to be in useable condition from the exterior, although the interior conditions are not known at this time.

Most of the asphalt paving should be removed and replaced on re-compacted earth and stone base. The access road to the back buildings and ball fields should be widened to 2 full lanes for emergency access if the ball fields continue to be utilized. Grades throughout the paved and other site areas should be adjusted and storm water inlet structures with underground piping installed to better direct and discharge the run-off. Depending on the ultimate use of the buildings, additional asphalt areas for parking and more concrete walks for access to buildings should also be installed. Any significant increase to the impervious area may require on-site storm water retention according to the current ordinances.

A new fire water line needs to be installed to supply buildings that require sprinkler systems and also at least one additional fire hydrant added near the middle of the site. The existing underground water distribution and sewer piping are close to 50 years old and in need of complete replacement.

The septic tank, pump and especially drain field are in need of repair in order to conform to NCDENR regulations. Current estimates to bring the septic system into compliance are in excess of \$100,000 in addition to the monthly charges by WSACC. An alternative to repairing and maintaining the existing system is to provide a gravity sewer line down to the new Bethel Elementary School site. Tim Lowder of WK Dickson, Civil Engineer for the new Bethel School, indicates the sewer system at the new site was designed to accommodate the sewer discharge from this facility also. He indicated that a gravity line to the new Bethel Elementary School would cross a road and five parcels of property, extending 3000 linear feet from the current site. Tim estimated the cost for this to be approximately \$250,000 (not including right-of-way purchase, if necessary). In this case, monthly charges would be normal sewer rates for metered water usage and monitoring fees would not be required.

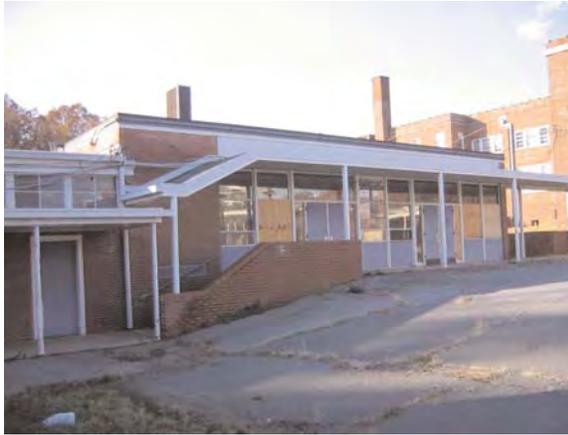
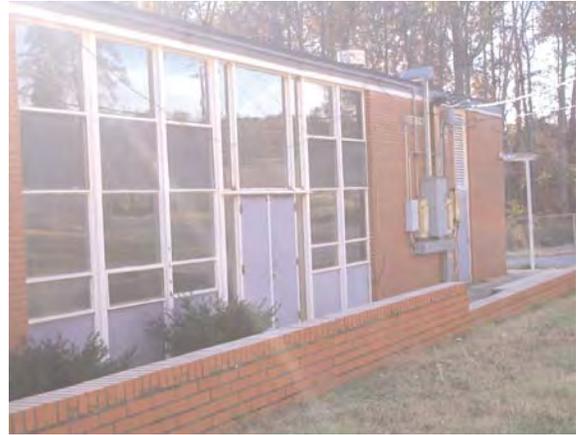
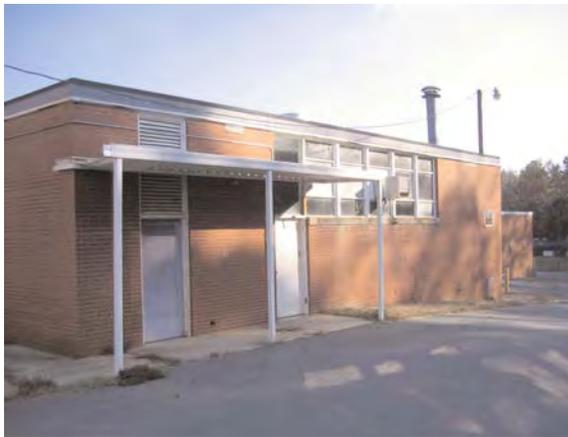
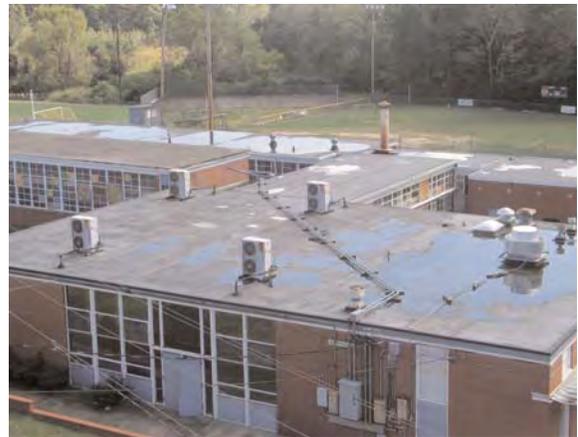
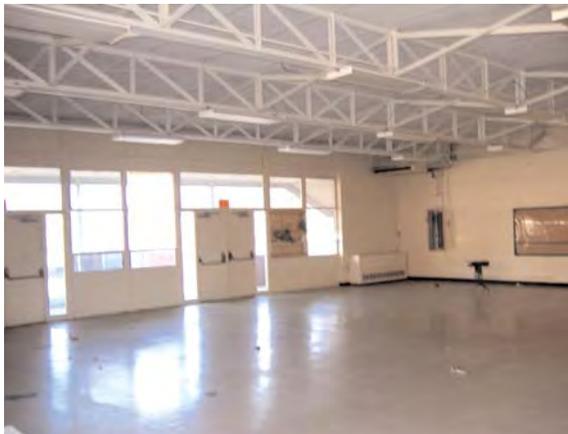
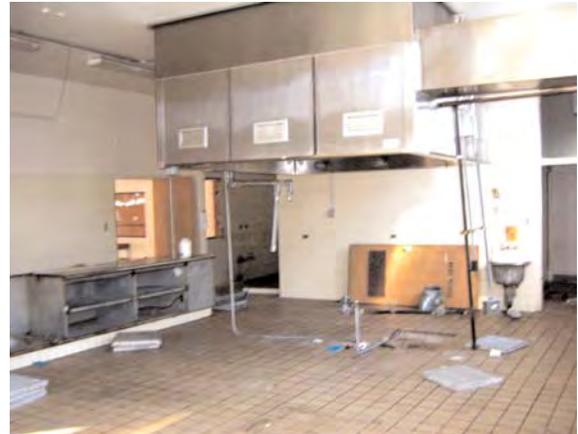
BUILDING D PHOTOS

As with the other buildings on campus, this building has been vacant for about a year and a half, but shows minimal signs of damage due to vandalism. The steam radiator heating system is original to the building, and the cooling units were added in 1987. Due to their age, inactivity and deterioration, the plumbing, mechanical and electrical systems are at the end of their life expectancy. The plumbing systems are suspected to have significant deterioration due to age and

Access to the roof was not provided, but the roof was observed from a distance to be a fairly new EPDM material. No signs of roof leaks were readily visible from the interior. However, a localized area of standing water was observed around the exhaust fan on the roof. The roofing is presumed to be in fairly good condition.

The building appears to be in satisfactory condition structurally. Some cracks in the CMU exterior bearing walls were observed, but not thought to be significant. The exterior glass curtain wall system is non-load bearing due to the steel frame. This system is very dated and completely non-insulating due to the 1/4" glass. This system shows signs of significant deterioration, and most of the glazing seals have been compromised.

The building has been previously documented to include some asbestos-containing materials such as pipe insulation and floor tile. In fact, all of the flooring in the dining area is tile documented to contain asbestos. Further studies into hazardous materials must be investigated prior to any proposed development.

Prior to any development of the building, a complete asbestos and hazardous materials survey must be performed and any materials identified removed. The Cabarrus County Building Department will require a current asbestos report prior to issuing a permit for any demolition or building activities. An asbestos survey has been performed and visually updated for the facility. However, this study is long out of date, and the building may actually contain more hazardous materials than indicated in previous reports due to more sophisticated modern testing methods.

The existing mechanical and electrical systems are past their normal life expectancy and have been dormant for the last 1 ½ years - which is usually fatal older systems. The boiler supplying steam to the heating system has been removed from Building E. In addition, the building has no ventilation which is required by the current Building Code. Therefore, these systems need to be completely replaced. Adequate heating, cooling and code compliant ventilation need to be provided for both the kitchen and dining areas. This is most easily accomplished with roof-top units that provide heating, cooling and ventilation. The roof structure appears adequate to handle some minor additional weight, but would require further structural investigation. Therefore, a number of smaller roof-top units should be utilized to minimize concentrating weight in any one area. The plumbing system is also in need of complete replacement due to age and apparent deterioration due to problems reported in the past. Replacing plumbing in this building will be costly, due to water piping within CMU walls and waste lines under the concrete floor slab. In addition, if the kitchen is to be re-utilized, a new grease trap will need to be installed on the exterior of the building and a new fire suppression system provided in for the kitchen exhaust hood. An overflow roof drainage system should also be installed to meet the current requirements of the code.

The existing exterior curtain wall system should be replaced with a modern, thermally broken storefront type system with insulating glass to provide better insulating values for the large expanses of glass. The exterior doors should also be replaced with better insulating and weatherstripped systems.

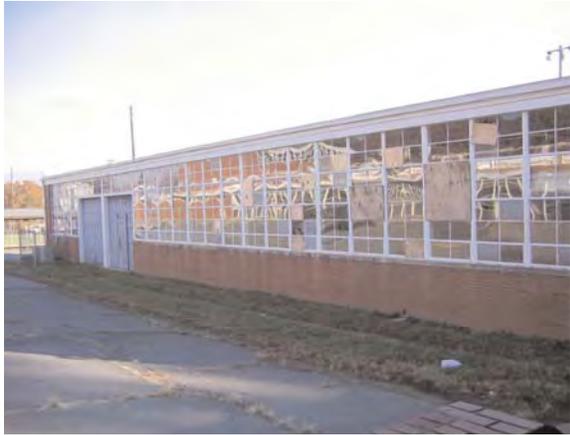
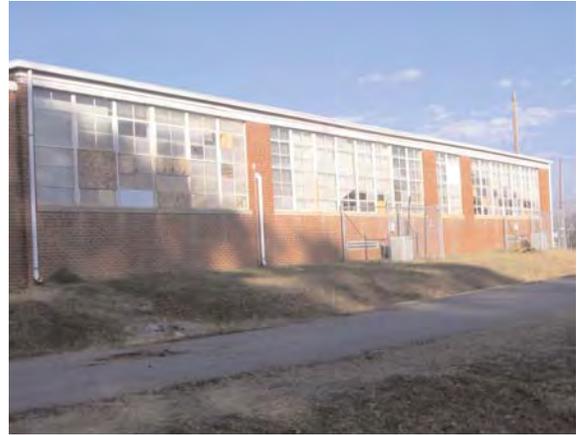
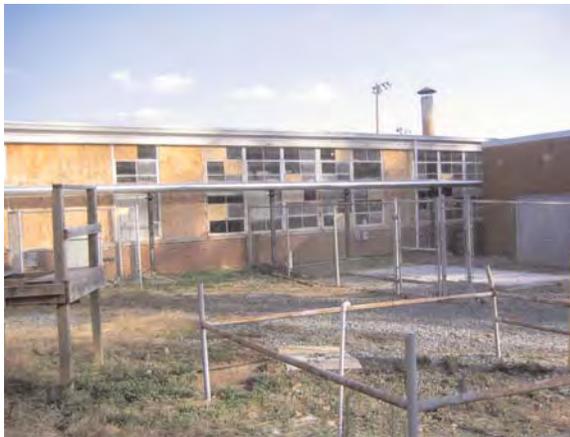
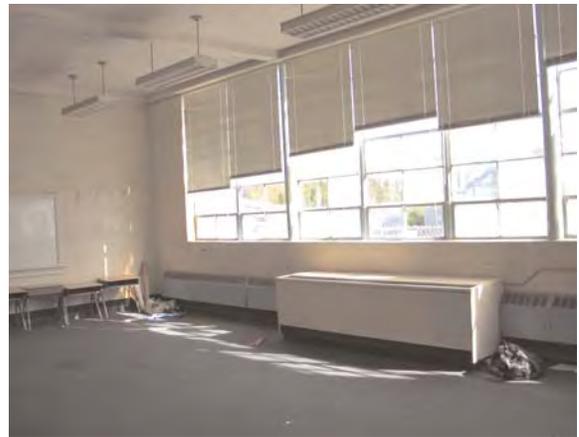
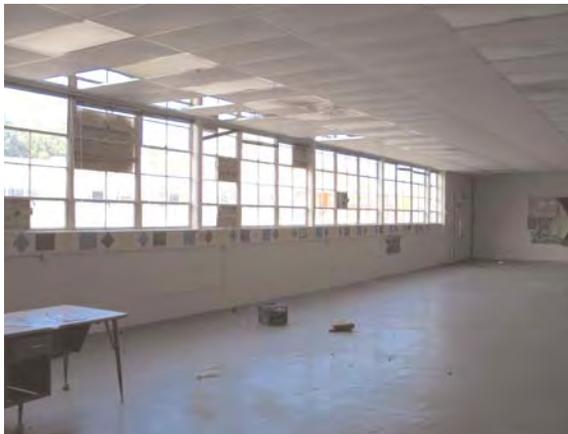
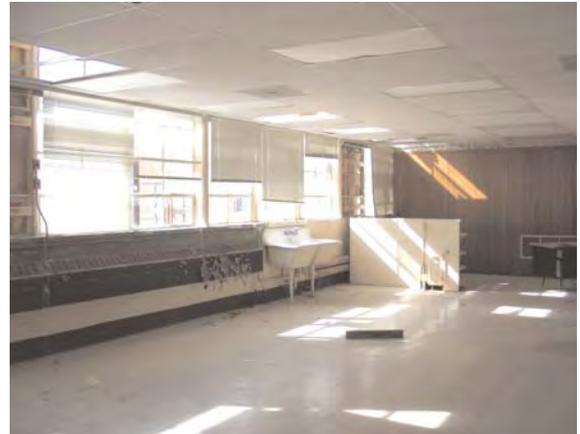
BUILDING E PHOTOS

As with the other buildings on campus, this building has been vacant for about a year and a half and shows significant signs of vandalism. Both the exterior and interior of the building has significant damage such as broken windows, damage to lay-in ceilings and damaged plumbing fixtures. The steam radiator heating system is original to the building and the cooling units were added in about 1997. Due to their age, inactivity and deterioration, the plumbing, heating and electrical systems are at the end of their life expectancy. The cooling system is less than 10 years old and presumed to be in operable condition, which must be verified. The plumbing systems are suspected to have significant deterioration due to age and ongoing problems reported in the past. Most of the exposed copper piping has been removed.

There is evidence of several roof leaks and from water entering through the clerestory windows that are not sealed or have been broken. Access to the roof was not provided; however, standing water was observed over almost the entire surface of the lower roof over the classroom area as water was not draining to the gutters.

The building appears to be in satisfactory condition structurally. However, some significant cracks in the CMU interior non-bearing walls were observed. The exterior glass curtainwall and clerestory window systems are non-load bearing due to the steel frame. These are both very dated and completely non-insulating due to the 1/4" glass. This system shows signs of significant deterioration and most of the glazing seals have been compromised.

The building has been previously documented to include some asbestos-containing materials such as pipe insulation and floor tile. Further studies into hazardous materials must be investigated prior to any proposed development.

Prior to any development of the building, a complete asbestos and hazardous materials survey must be performed and any materials identified removed. The Cabarrus County Building Department will require a current asbestos report prior to issuing a permit for any demolition or building activities. An asbestos survey has been performed and visually updated for the facility.

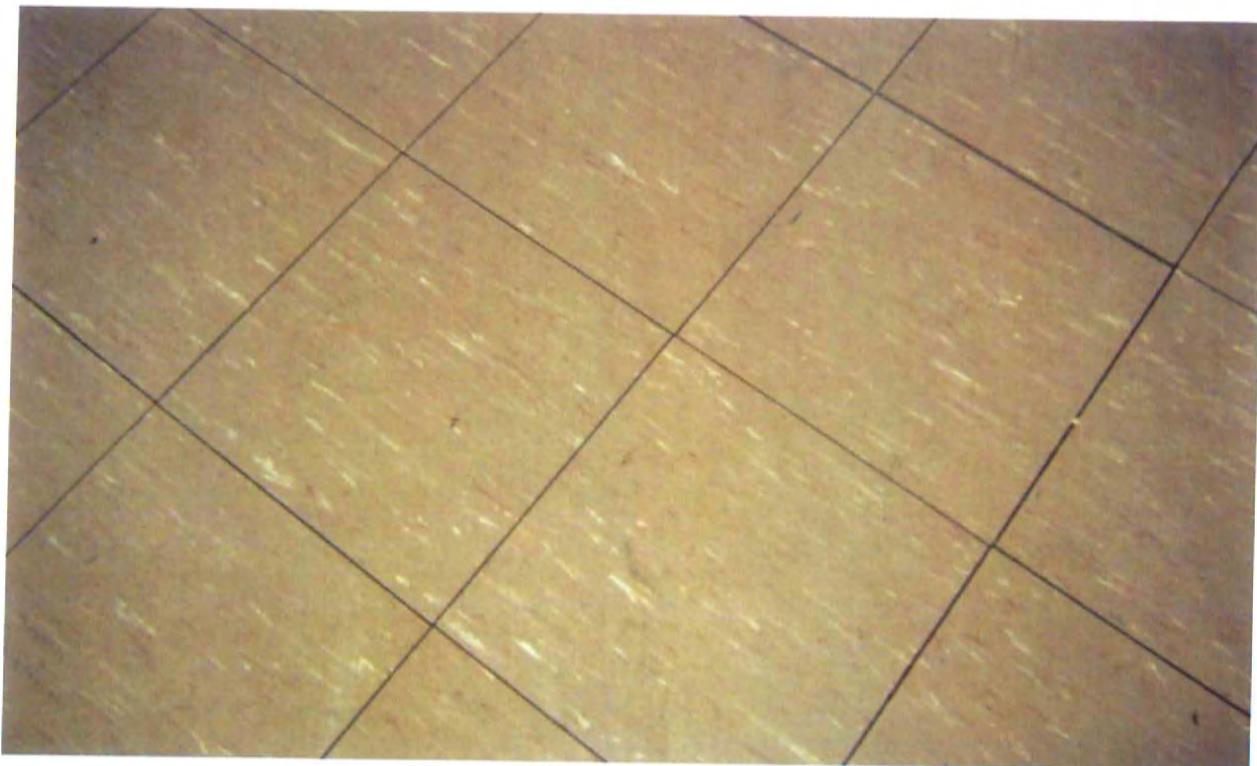
Photograph A-1 – 12"x12" brown floor tile and mastic

HA NO.	DESCRIPTION	MATERIAL LOCATION	PERCENT/TYPE ASBESTOS	CONDITION	ESTIMATED QUANTITY
1	12"x12" brown floor tile and mastic	Throughout	2% Chrysotile / 4% Chrysotile	Damaged	20,000 ft ²
4	Black mastic dots	Behind white boards	4% Chrysotile	Good	4,000 ft ²
10	9"x9" dotted floor tile and mastic	Room 11	3% Chrysotile / 3% Chrysotile	Damaged	500 ft ²
11	12"x12" beige floor tile and mastic	Adjacent to room 11	2% Chrysotile / 5% Chrysotile	Damaged	500 ft ²
13	Roof flashing	Roof	2% Chrysotile	Damaged	800 ft ²
14	Roof membrane	Center upper roof	3% Chrysotile	Damaged	5000 ft ²
15	Black mastic	Roof penetrations	3% Chrysotile	Damaged	100 ft ²
18	Pipe insulation	Crawlspace	79% Chrysotile	Damaged	1000 ft ²

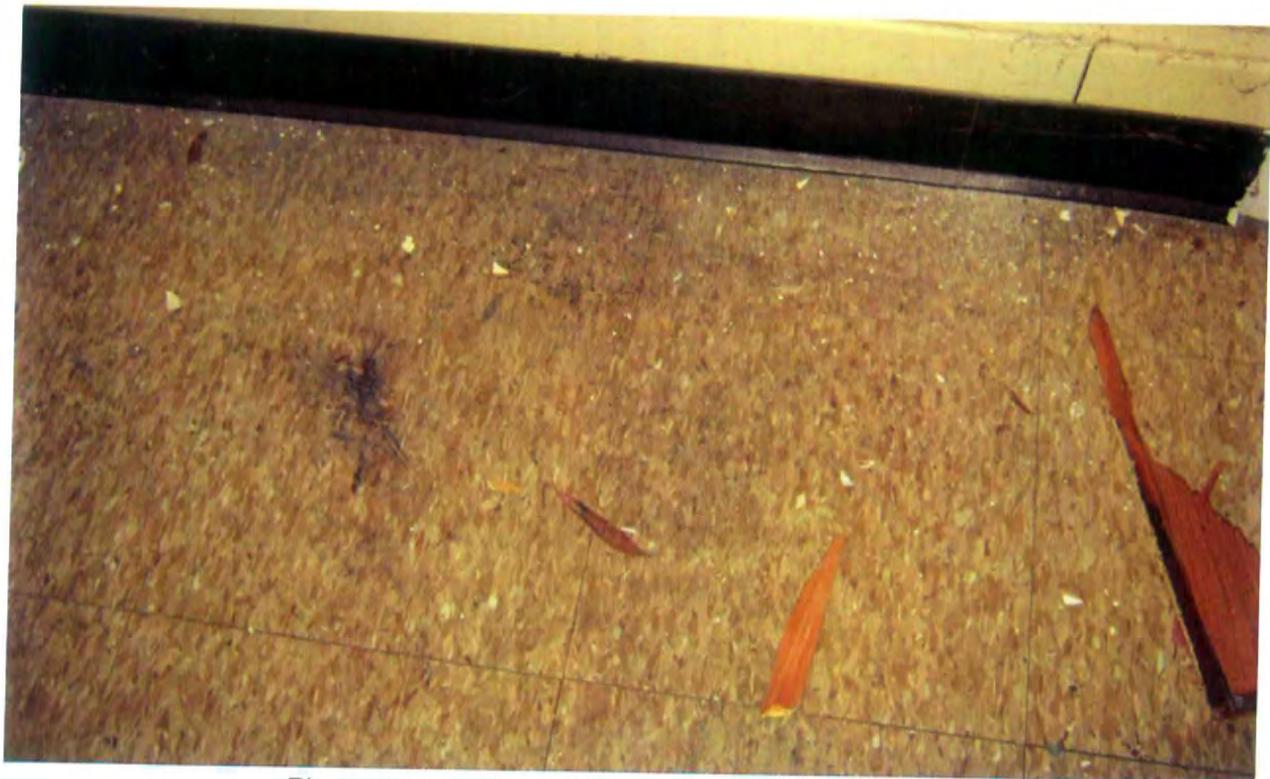
Photograph A-11 – 12"x12" beige floor tile and mastic

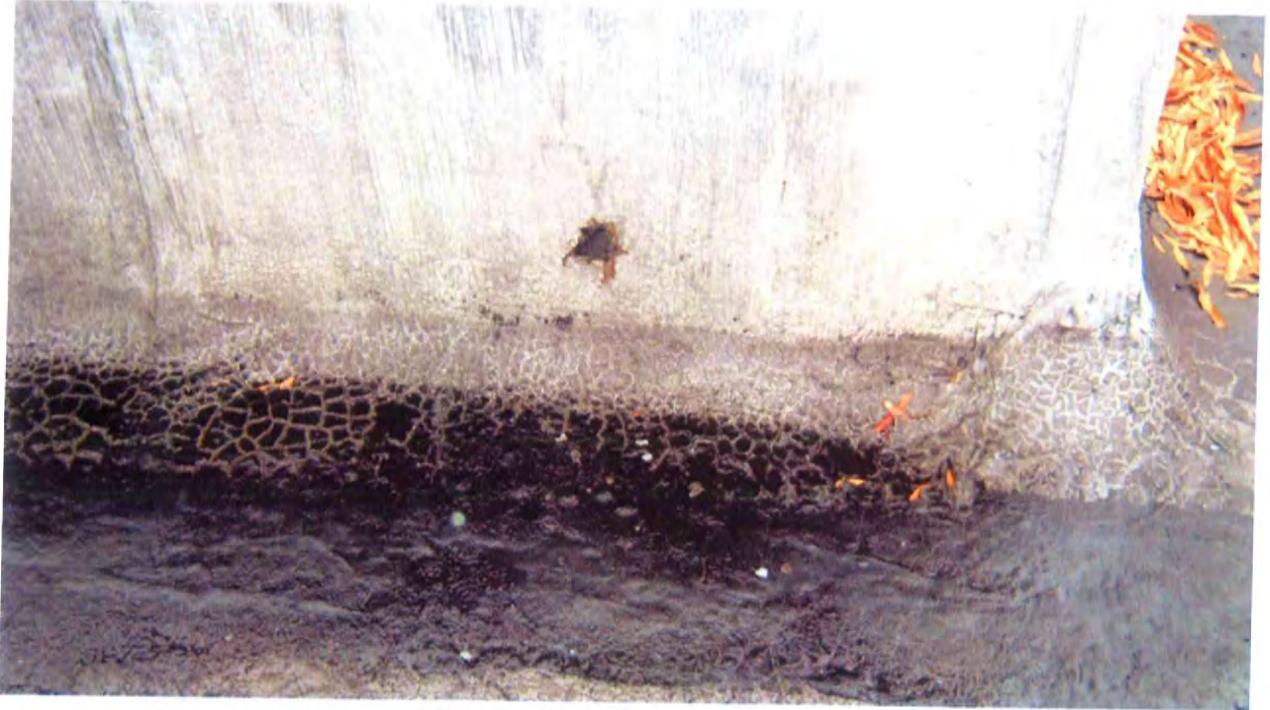
Photograph A-13 – roof flashing

SAMPLE NO.	DESCRIPTION	MATERIAL LOCATION	PERCENT/TYPE ASBESTOS	CONDITION	ESTIMATED QUANTITY
8-10	Exterior caulk	Exterior door / window frames	2% Chrysotile	Damaged	3 door frames, 70 window frames
14-16	Interior window caulk	Throughout	2% Chrysotile	Good	*
17-21	9"x9" beige/brown floor tile and mastic	Classrooms (below carpet)	2% Chrysotile / 3% Chrysotile	Good	5000 ft ²
25-27	Window glazing	Exterior windows	2% Chrysotile	Significantly damaged	*
28-30	Interior door insulation	Throughout	6% Chrysotile, 3% Amosite	Good	22 doors
39-41	12"x12" brown floor tile and mastic	Classroom storage areas	2% Chrysotile / 2% Chrysotile	Good	200 ft ²
45-47	Mastic below 12"x12" white floor tile	Classroom storage areas	NAD / 2% Chrysotile	Good	300 ft ²
56-58	Roof flashing	Roof	10% Chrysotile	Good	500 ft ²

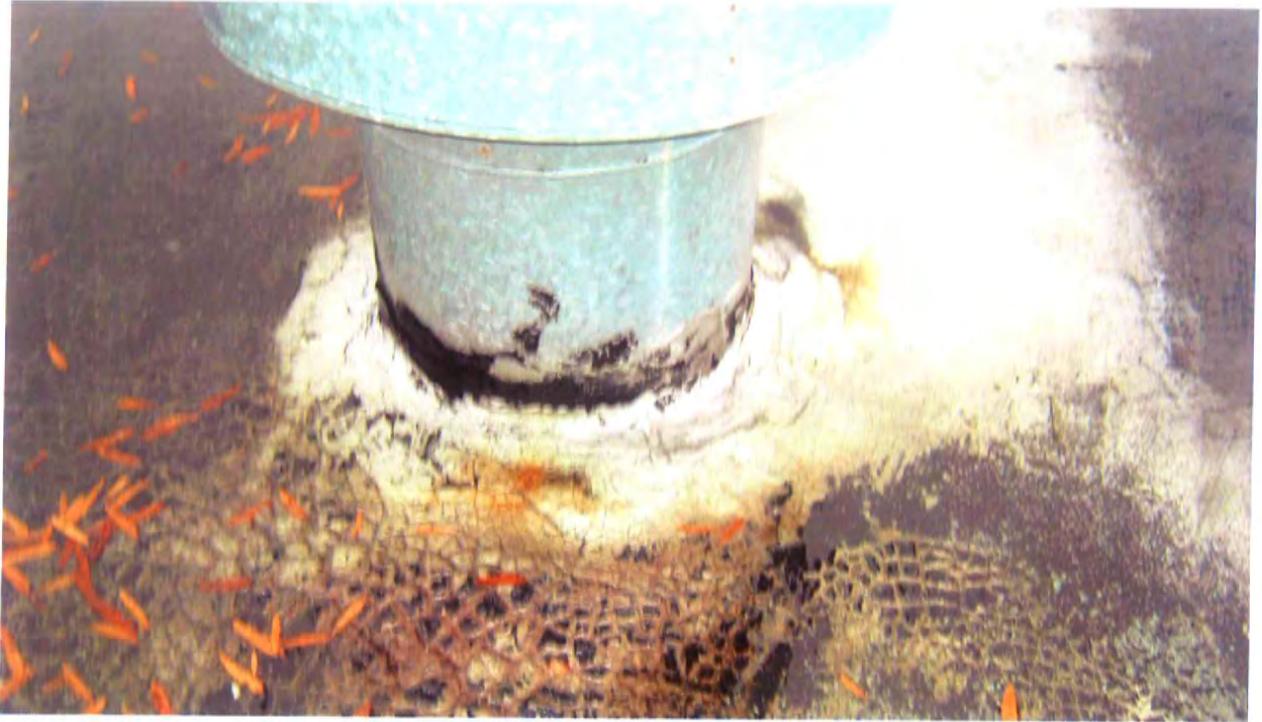
Photograph A-15 – black mastic

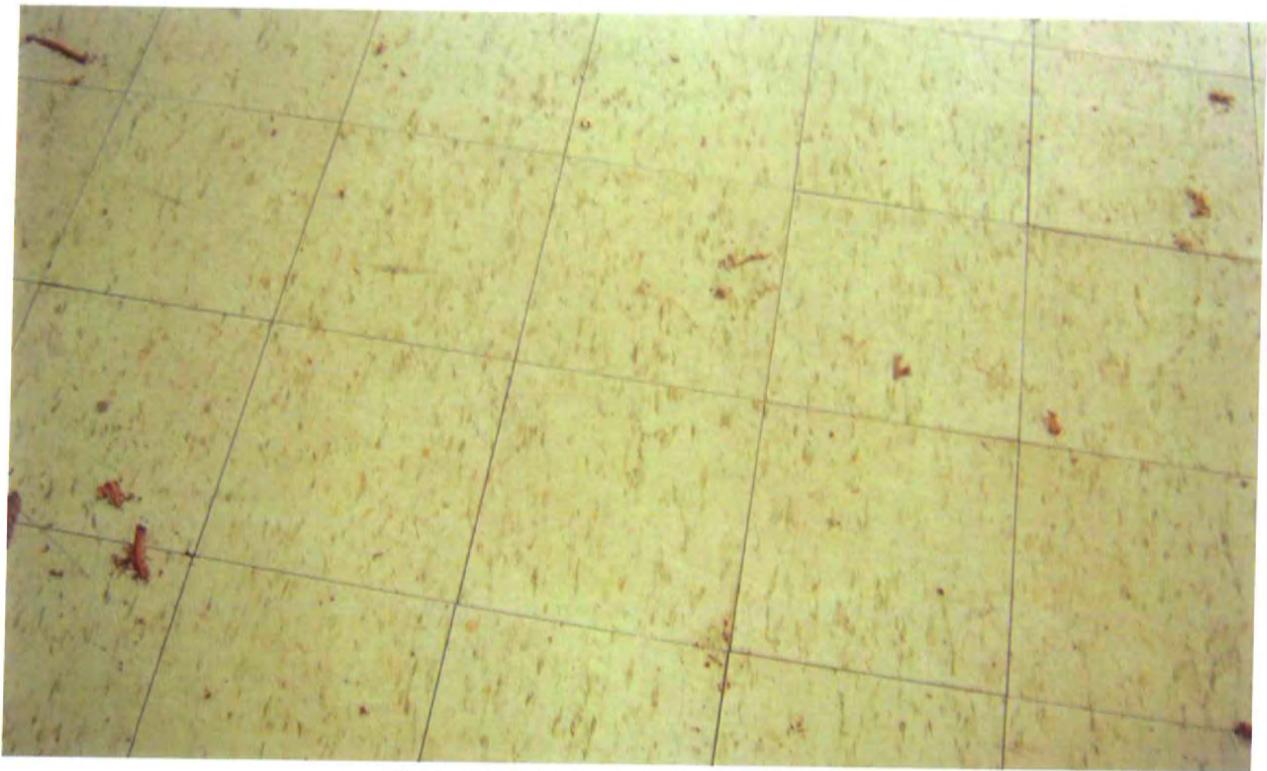
Photograph B-1 – 9"x9" white floor tile

HA NO.	DESCRIPTION	MATERIAL LOCATION	PERCENT/TYPE ASBESTOS	CONDITION	ESTIMATED QUANTITY
1	9"x9" white floor tile and mastic	Lobby	2% Chrysotile / 2% Chrysotile	Damaged	550 ft ²
4	Pipe insulation and elbows	Locker rooms	4% Chrysotile	Significantly damaged	200 ft
4	Tank insulation	Locker rooms	4% Chrysotile	Significantly damaged	300 ft ²
5	9"x9" dotted floor tile and mastic	Locker rooms	2% Chrysotile / 3% Chrysotile	Significantly damaged	50 ft ²

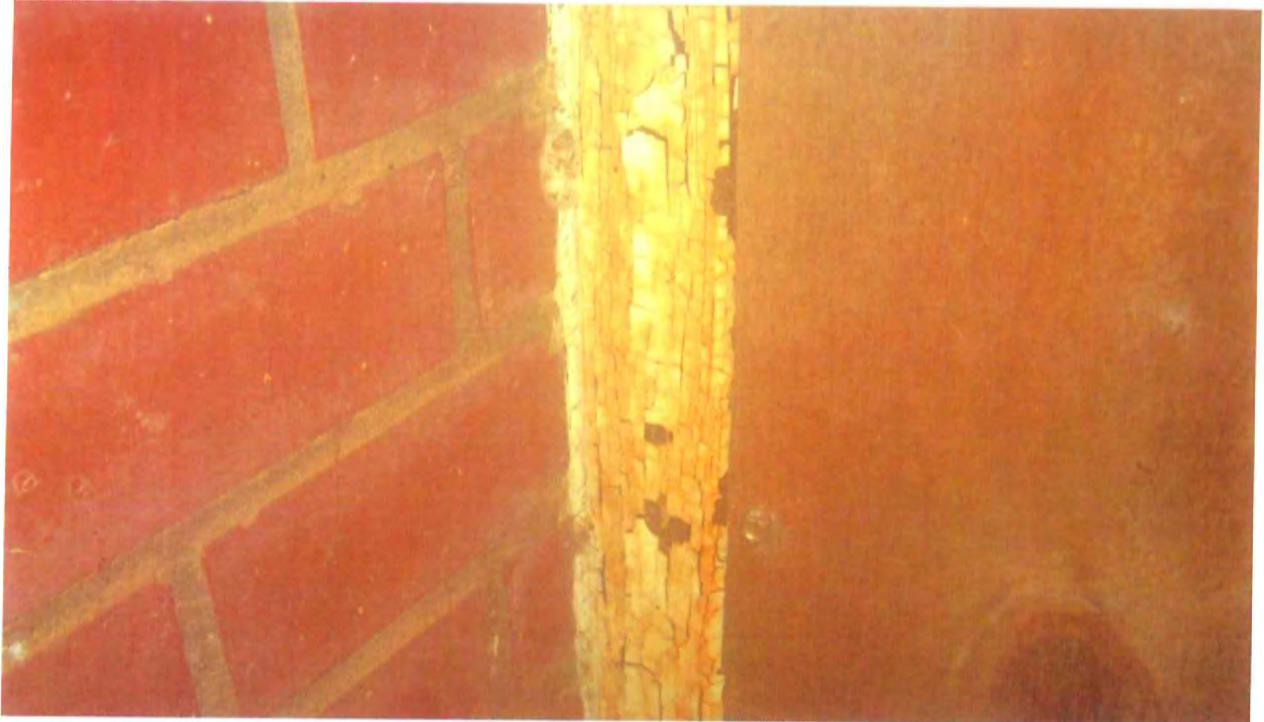
Photograph C-8 – exterior caulk

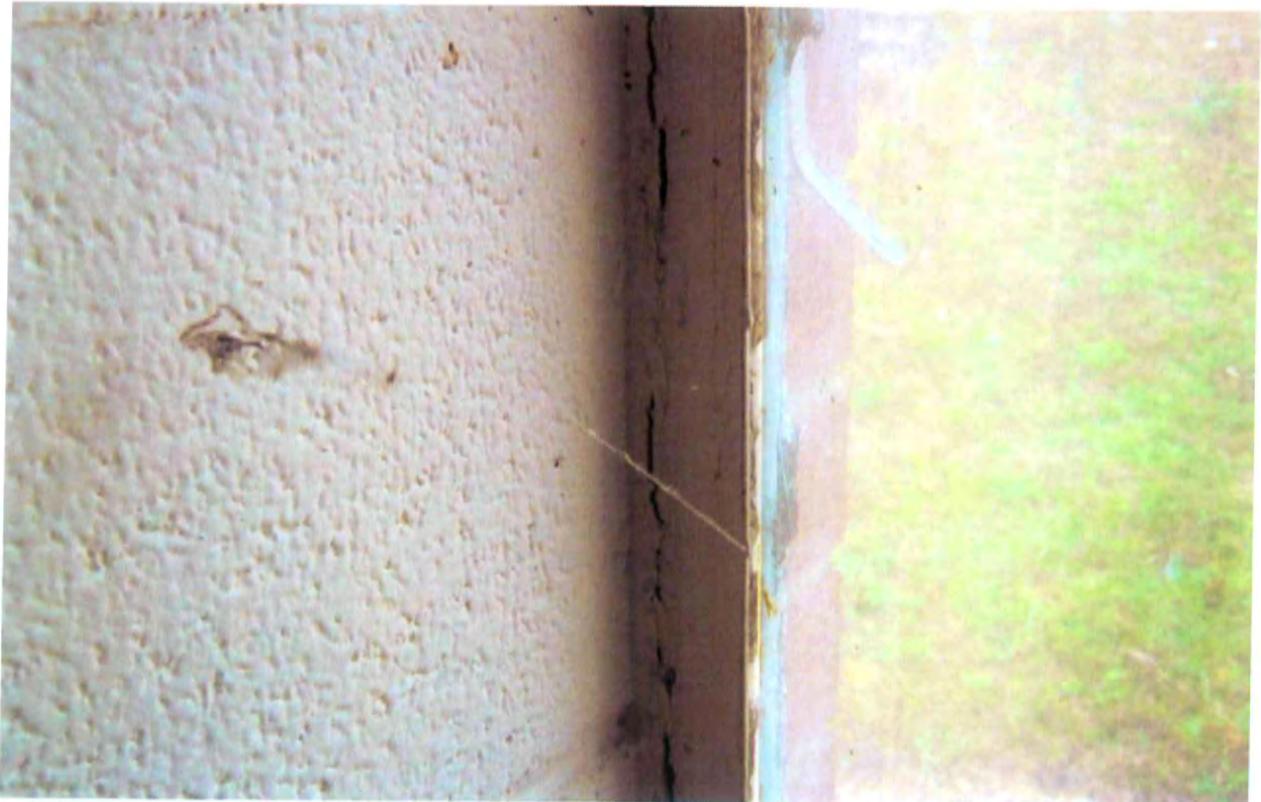
Photograph C-14 – interior window caulk

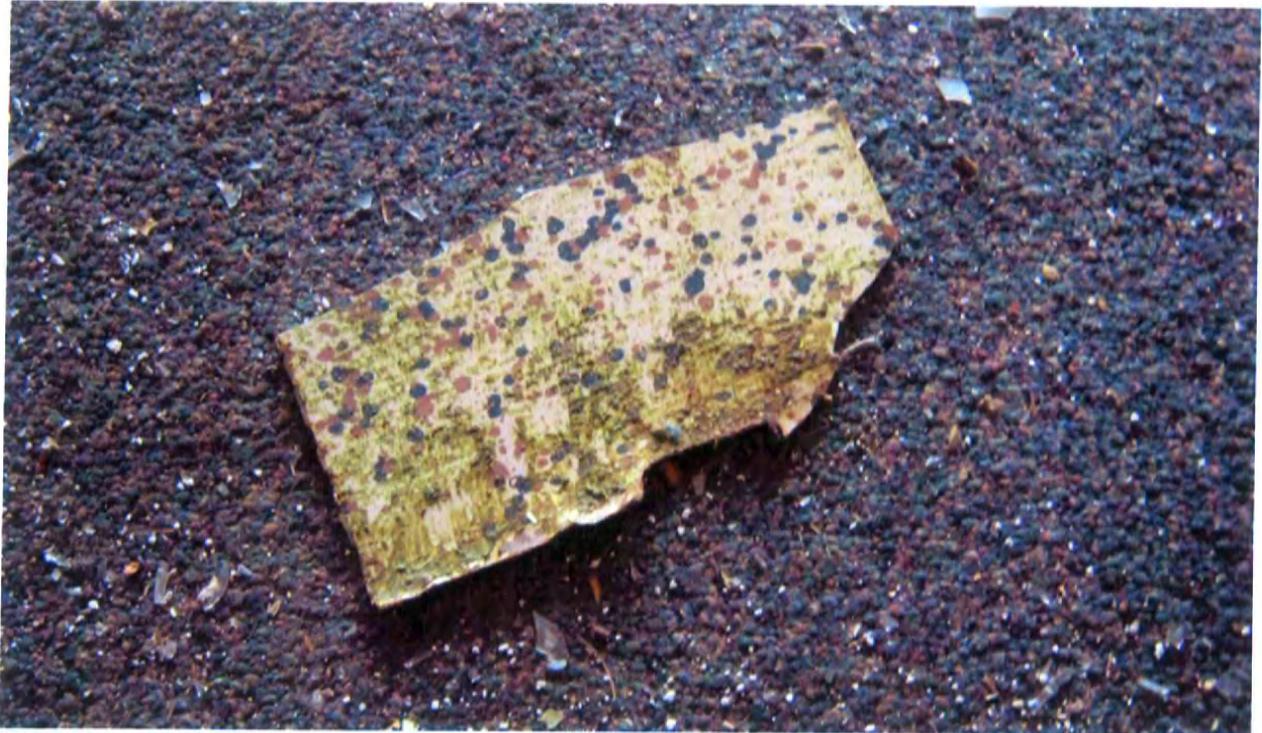
Photograph C-17 – 9"x9" beige / brown floor tile and mastic

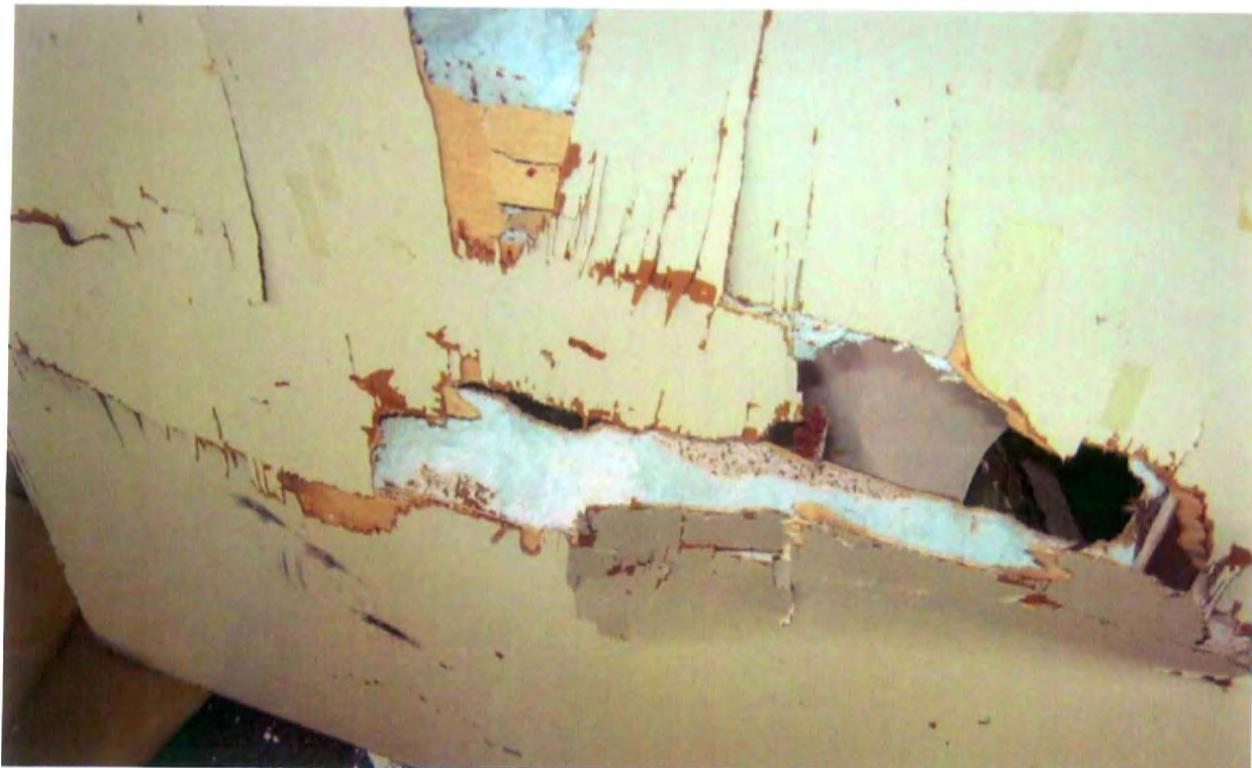
Photograph C-28 – interior door insulation

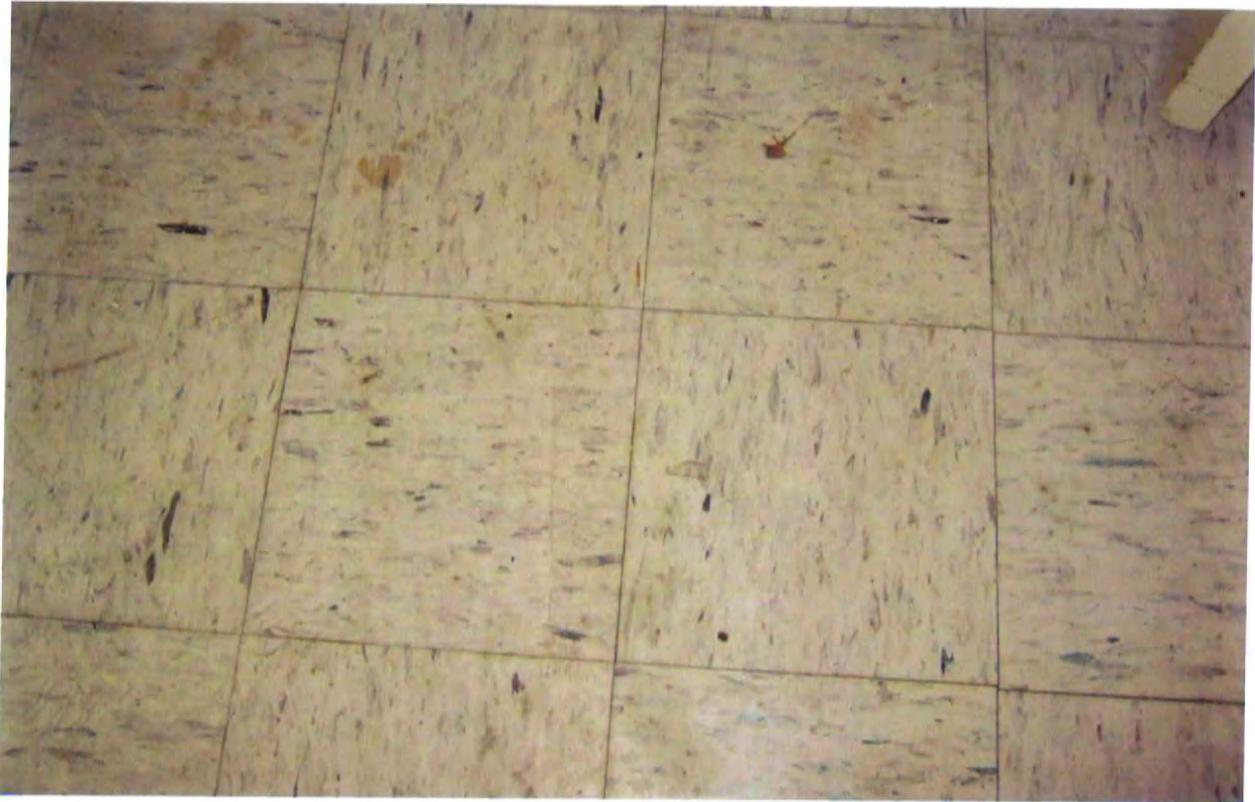
Photograph C-45 – mastic below 12"x12" white floor tile

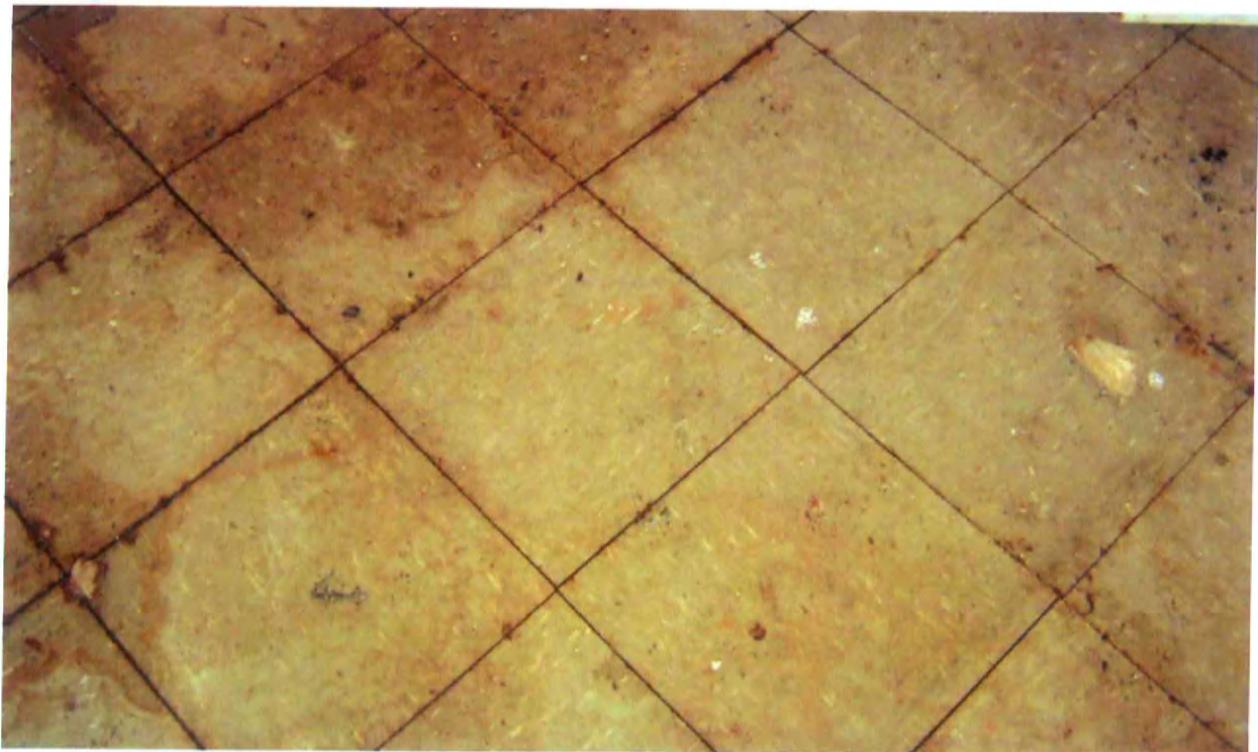
Photograph D-1 – 12"x12" grey and white floor tile and mastic

SAMPLE NO.	DESCRIPTION	MATERIAL LOCATION	PERCENT/TYPE ASBESTOS	CONDITION	ESTIMATED QUANTITY
1-5	12"x12" grey/white floor tile and mastic	Dining room	2% Chrysotile / 2% Chrysotile	Damaged	2500 ft ²
6-8	Interior window caulk	Exterior windows	3% Chrysotile	Significantly damaged	24 window frames
17-19	Exterior caulk	Exterior doors / windows	3% Chrysotile	Significantly damaged	6 door frames, **
20-22	Door insulation	Throughout	3% Chrysotile, 6% Amosite	Good	5 doors

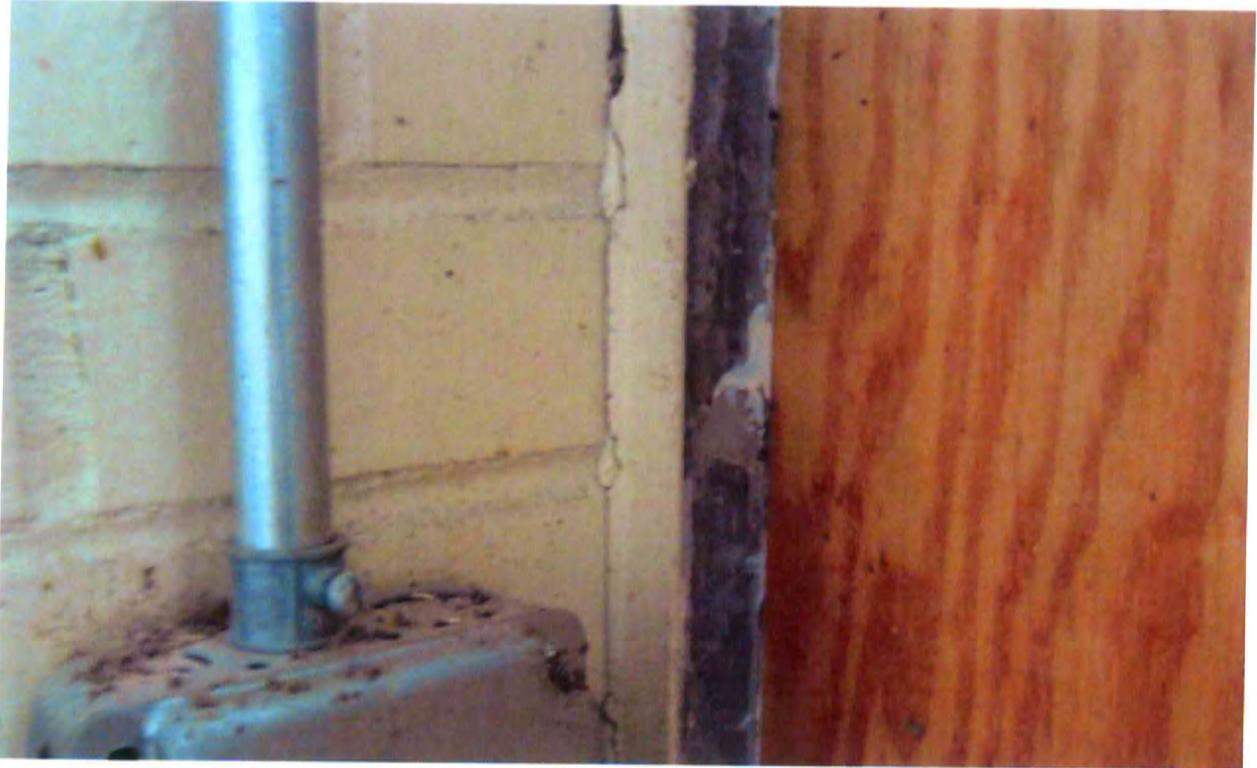
Photograph D-6 – interior window caulk

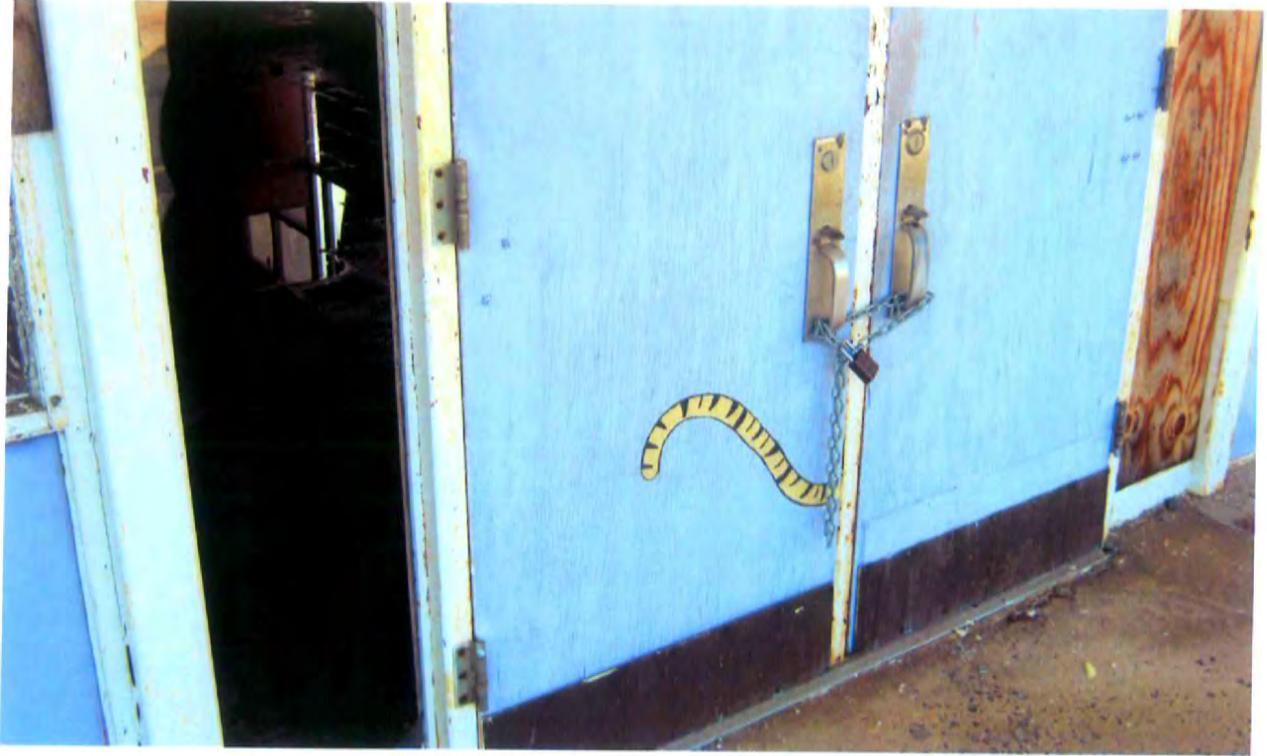
Photograph D-20 – door insulation

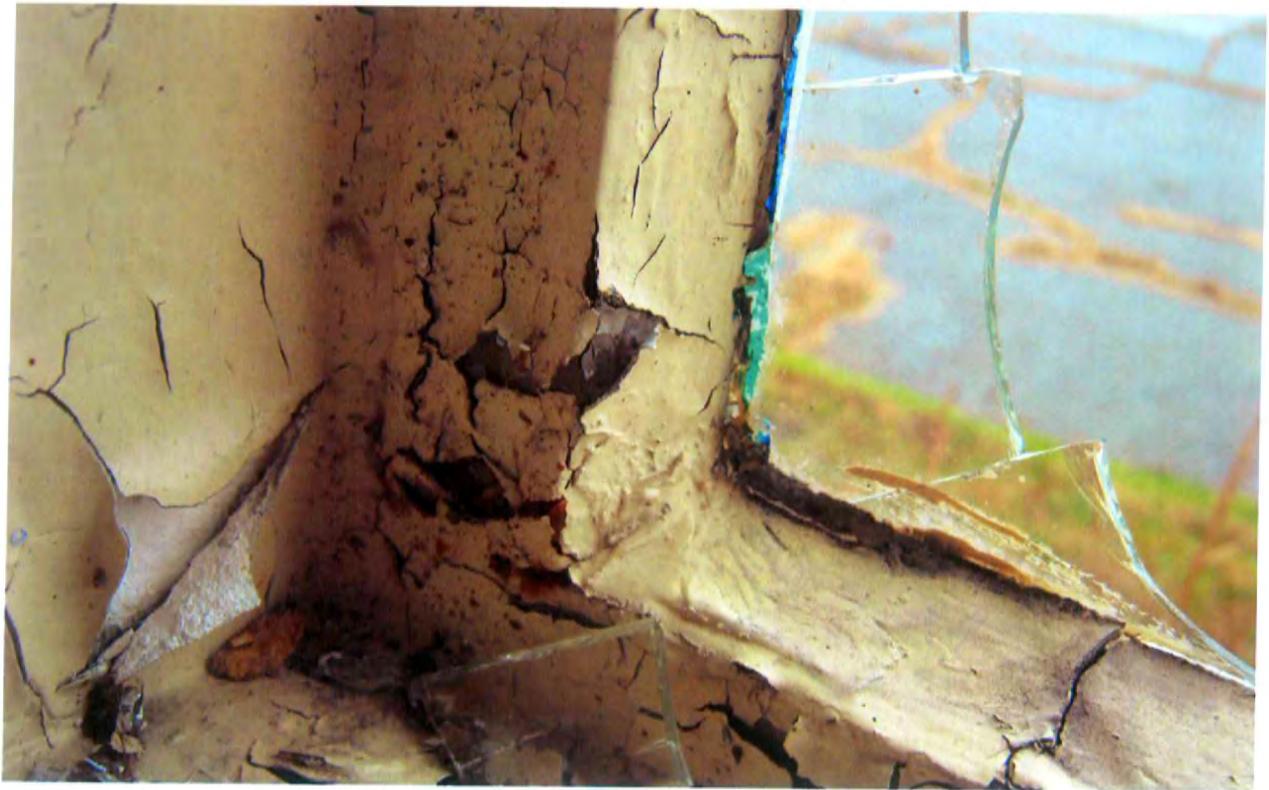
Photograph E-1 – interior window glazing

SAMPLE NO.	DESCRIPTION	MATERIAL LOCATION	PERCENT/TYPE ASBESTOS	CONDITION	ESTIMATED QUANTITY
1-3	Interior window glazing	Exterior windows	2% Chrysotile	Significantly damaged	150 window frames
10-12	Interior window caulk	Exterior windows	3% Chrysotile	Damaged	***
13-15	Mastic below 12"x12" beige floor tile	Throughout	NAD / 4% Chrysotile	damaged	3000 ft ²
16-18	Mastic below 12"x12" brown / grey floor tile	Art room patch	NAD / 2% Chrysotile	damaged	200 ft ²
22-24	Carpet adhesive	Classrooms	4% Chrysotile	Good	4000 ft ²
28-30	9"x9" black floor tile and mastic	Classroom storages (below carpet)	4% Chrysotile, 2% Chrysotile	Good	500 ft ²
31-33	Mastic below 12"x12" beige / brown floor tile	Art room patch	NAD / 3% Chrysotile	Good	50 ft ²
34-36	9"x9" black floor tile and mastic	Classroom 1 (below carpet)	4% Chrysotile / 2% Chrysotile	Good	300 ft ²

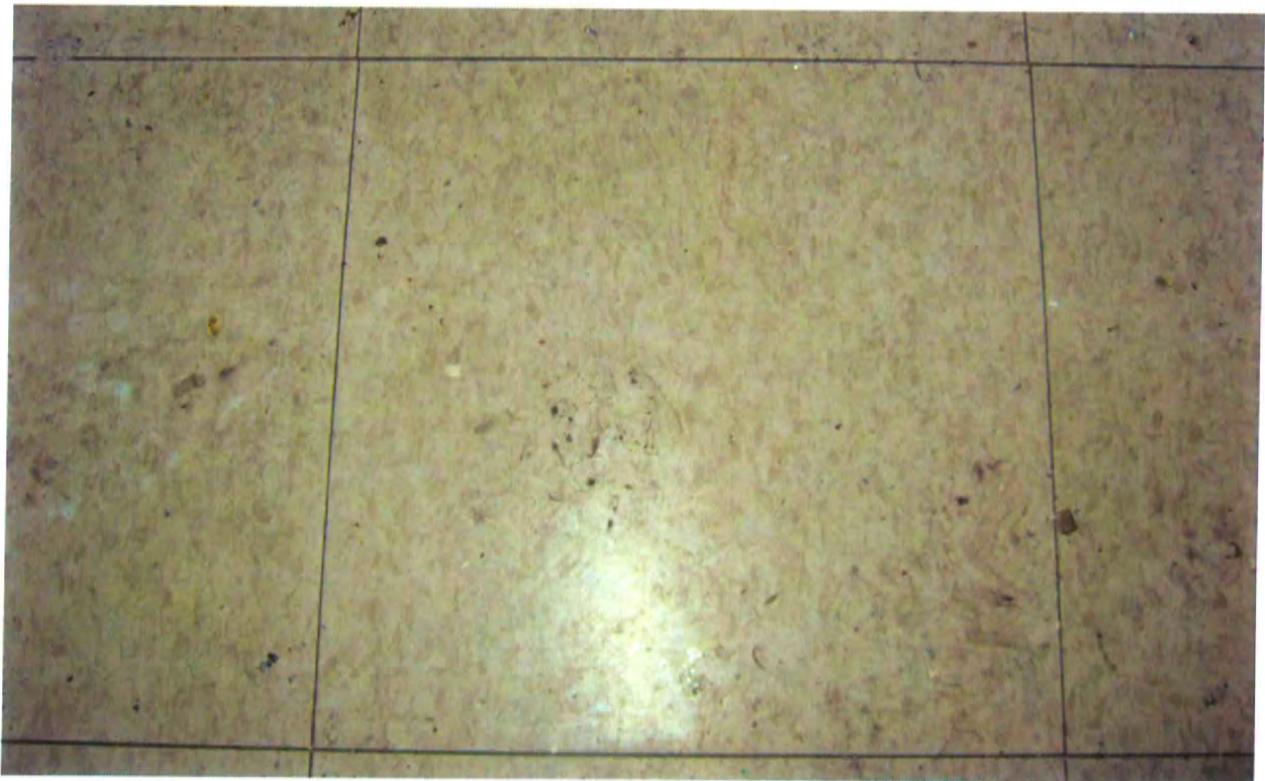
Photograph E-13 – mastic below 12"x12" beige floor tile
