ADVERTISEMENT FOR SEALED BIDS
SALE OF COUNTY PROPERTY
(Old Bethel School Property)

FEASIBILITY ASSESSMENT OF OLD BETHEL ELEMENTARY SCHOOL

Asbestos Survey Report

Old Bethel Elementary School

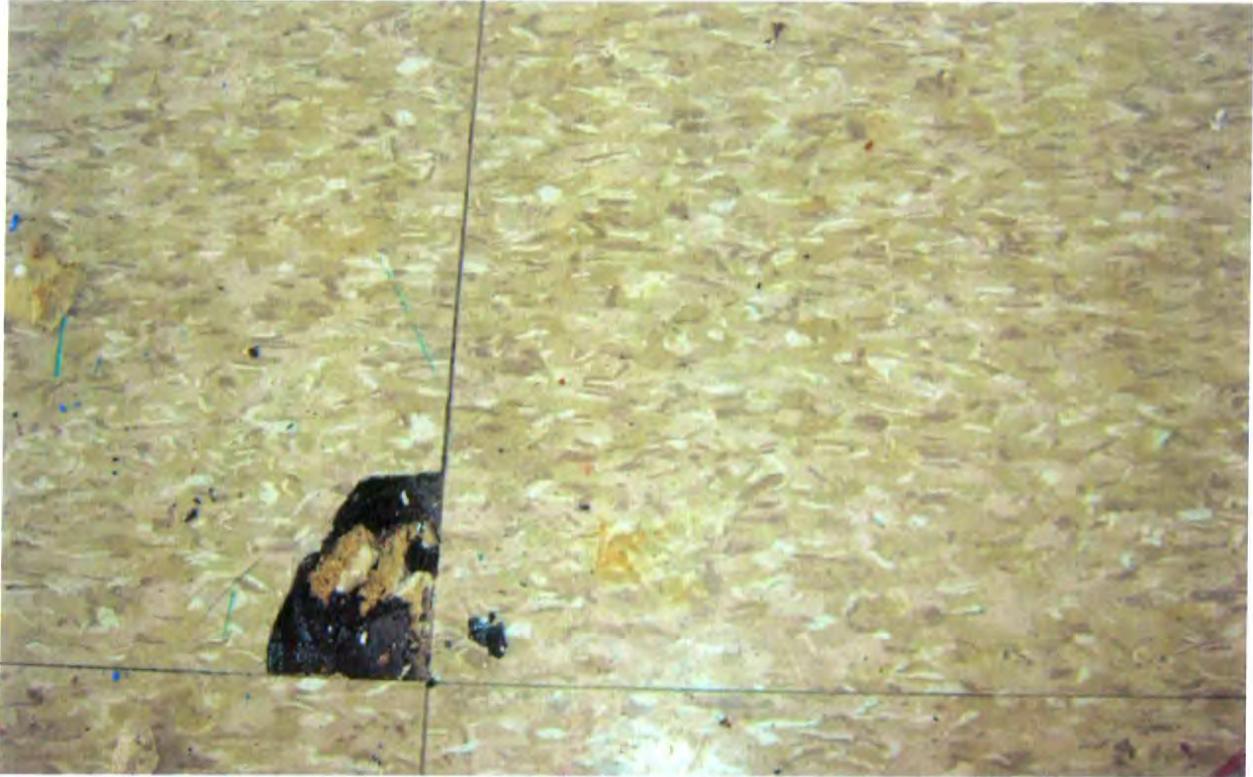
Photograph E-16 – mastic below 12"x12" brown / grey floor tile
Photograph E-31 – mastic below 12"x12" beige / brown floor tile (same material)
